**Smoky Canyon Mine  
Non-Time-Critical Removal Action (NTCRA) – 2015 Activities  
Pole Canyon Overburden Disposal Area**

**Weekly Construction Report**

Prepared by: Formation Environmental (on behalf of the J.R. Simplot Company)

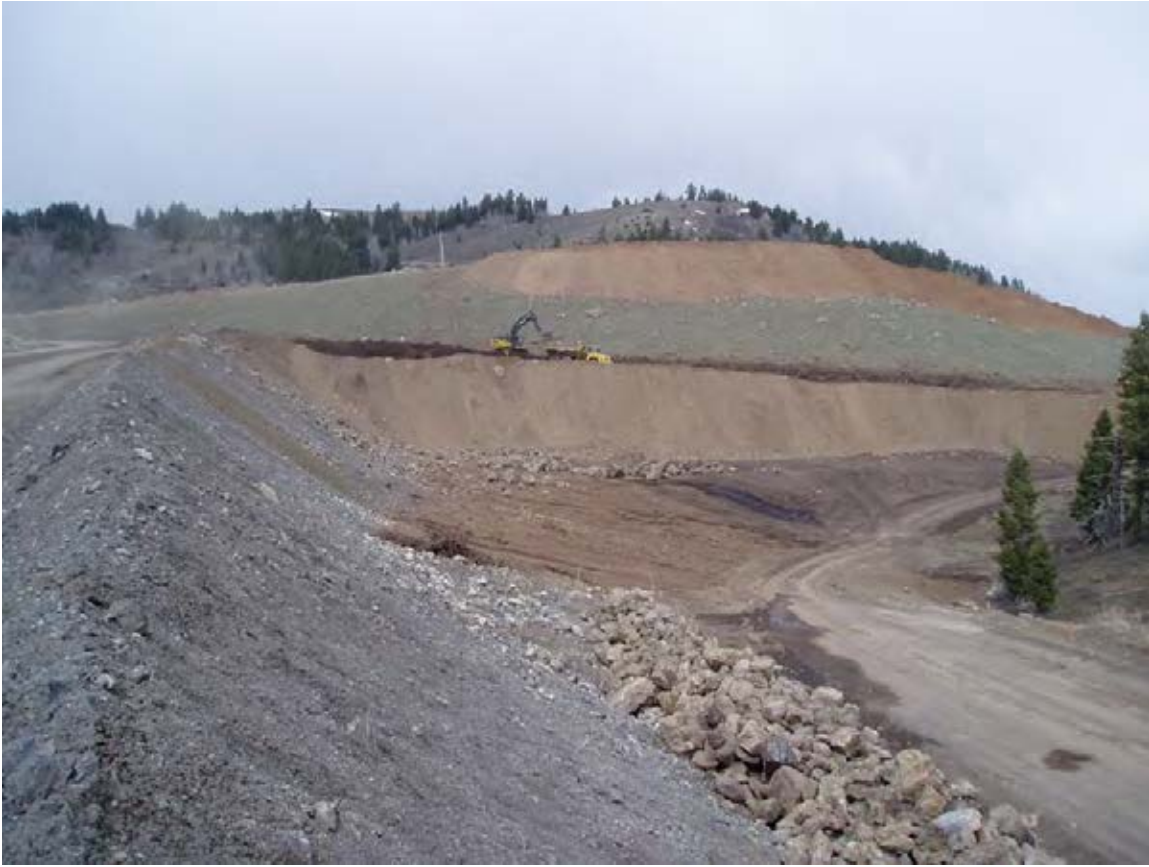
Photograph 2: Excavator loading haul trucks with chert on south side ODA. Note groundwater weeps at the toe of slopes in mid and foreground. South Central Sedimentation Basin will be constructed to the right of photograph.

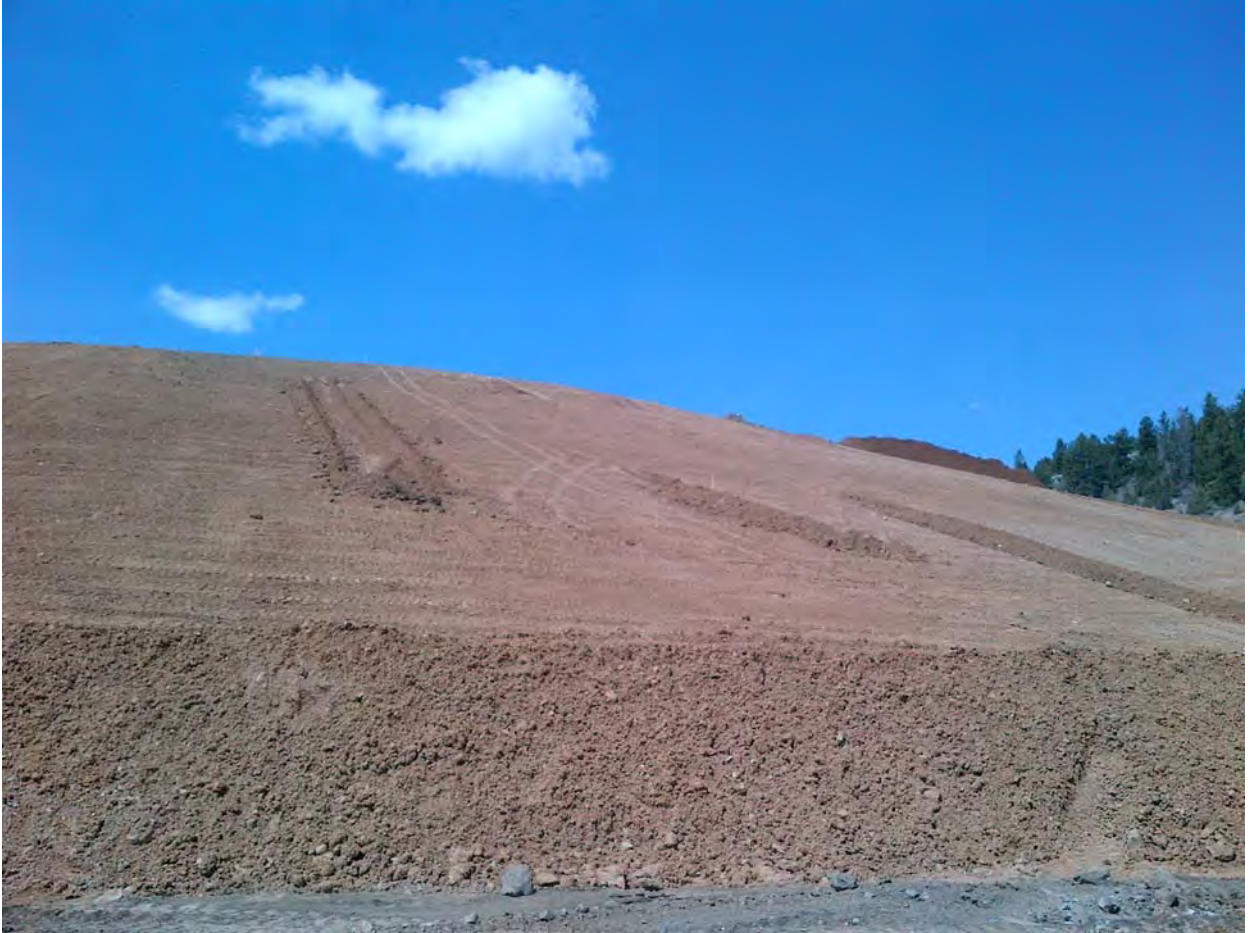
Photograph 2: Test trench excavations on east slope of ODA cover to check chert thickness.

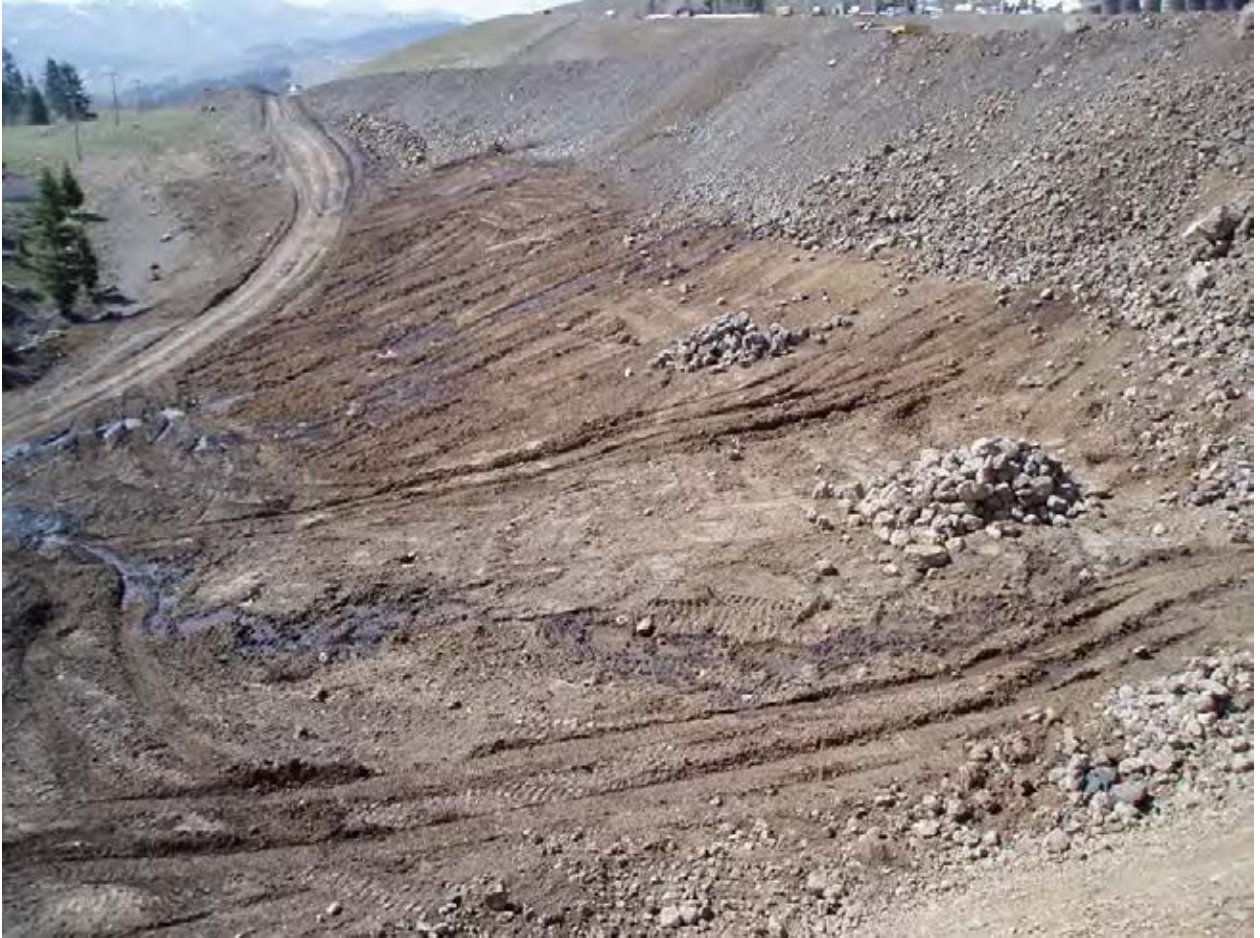
Photograph 4. Looking south at groundwater seeps immediately west of south Central Sedimentation Basin area.

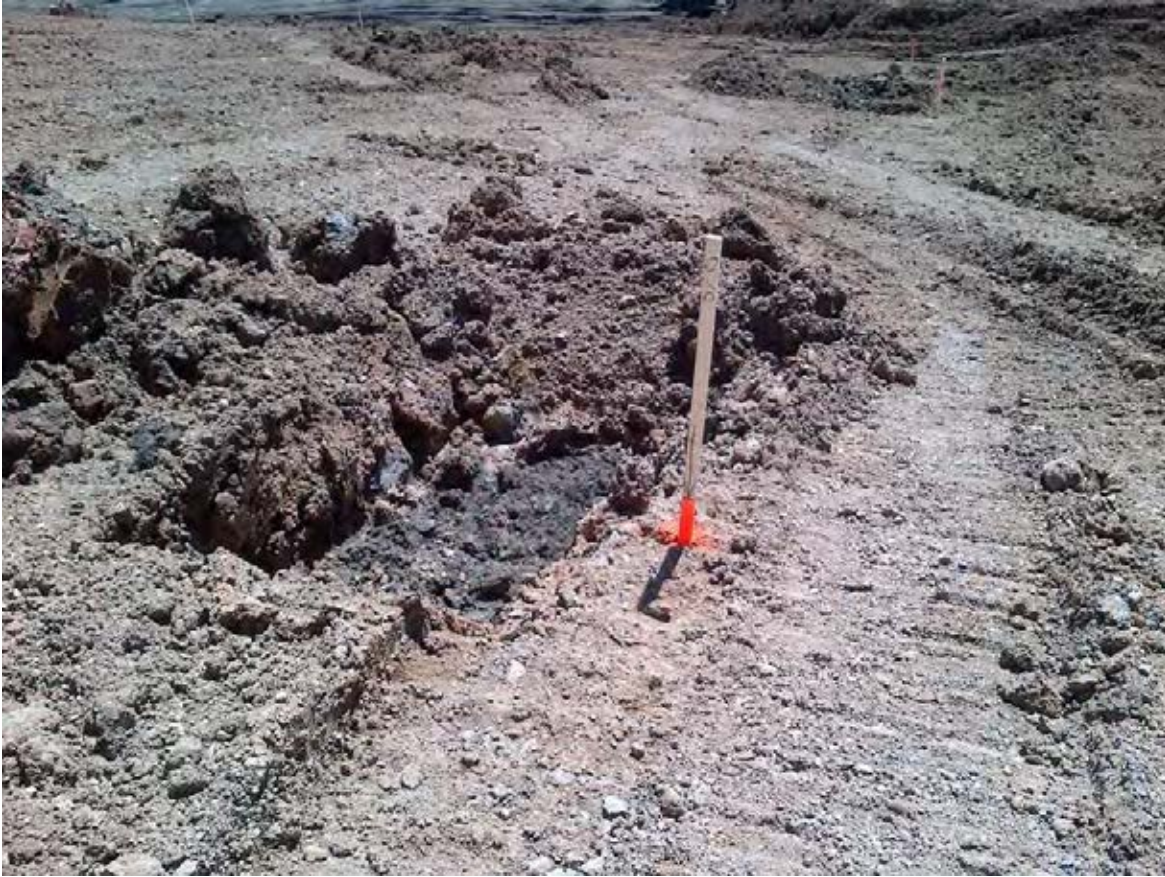
Photograph 4. Excavation of test pits and placement of grade stakes on east slope of ODA indicating the amount of chert placement needed to achieve minimum depth required.

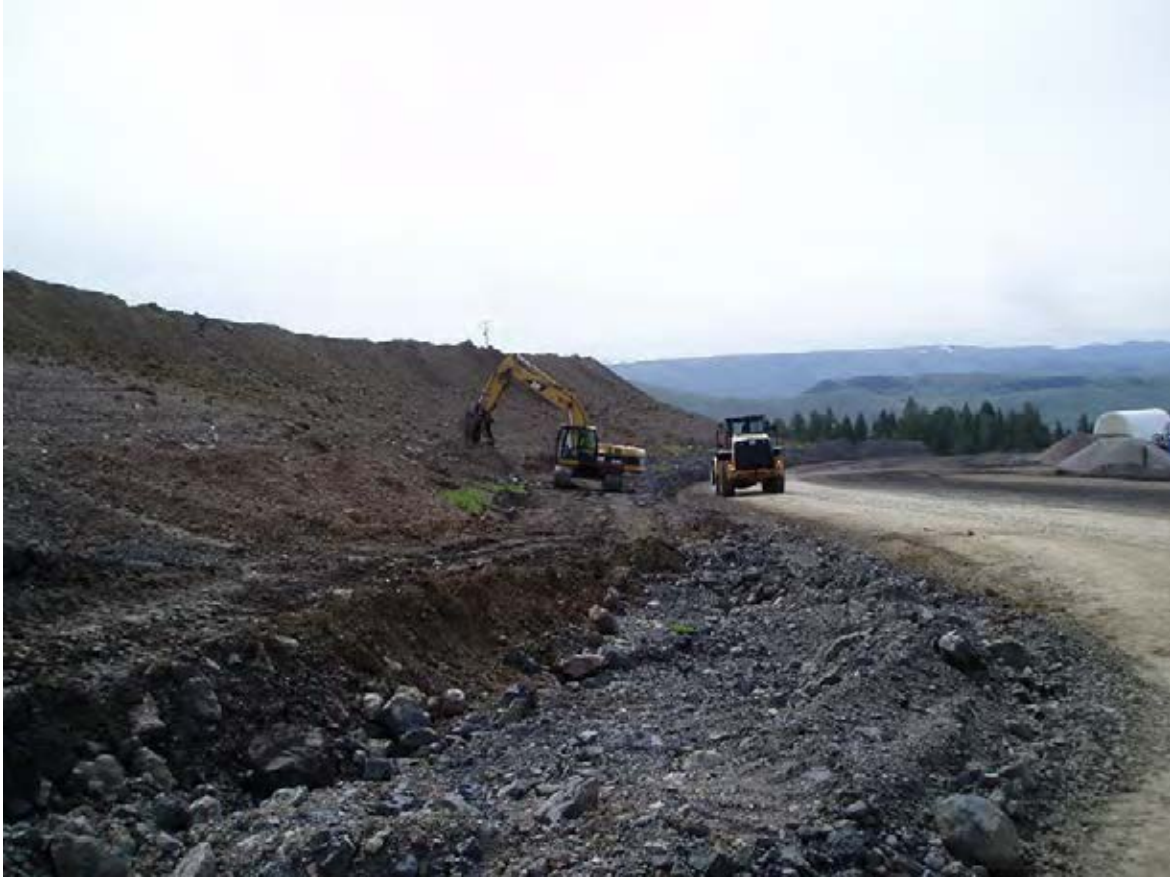
Photograph 3: Contractor removing oversized rock fragments from chert placed on east side ODA adjacent to and east of mine haul road (ES-R1-T).

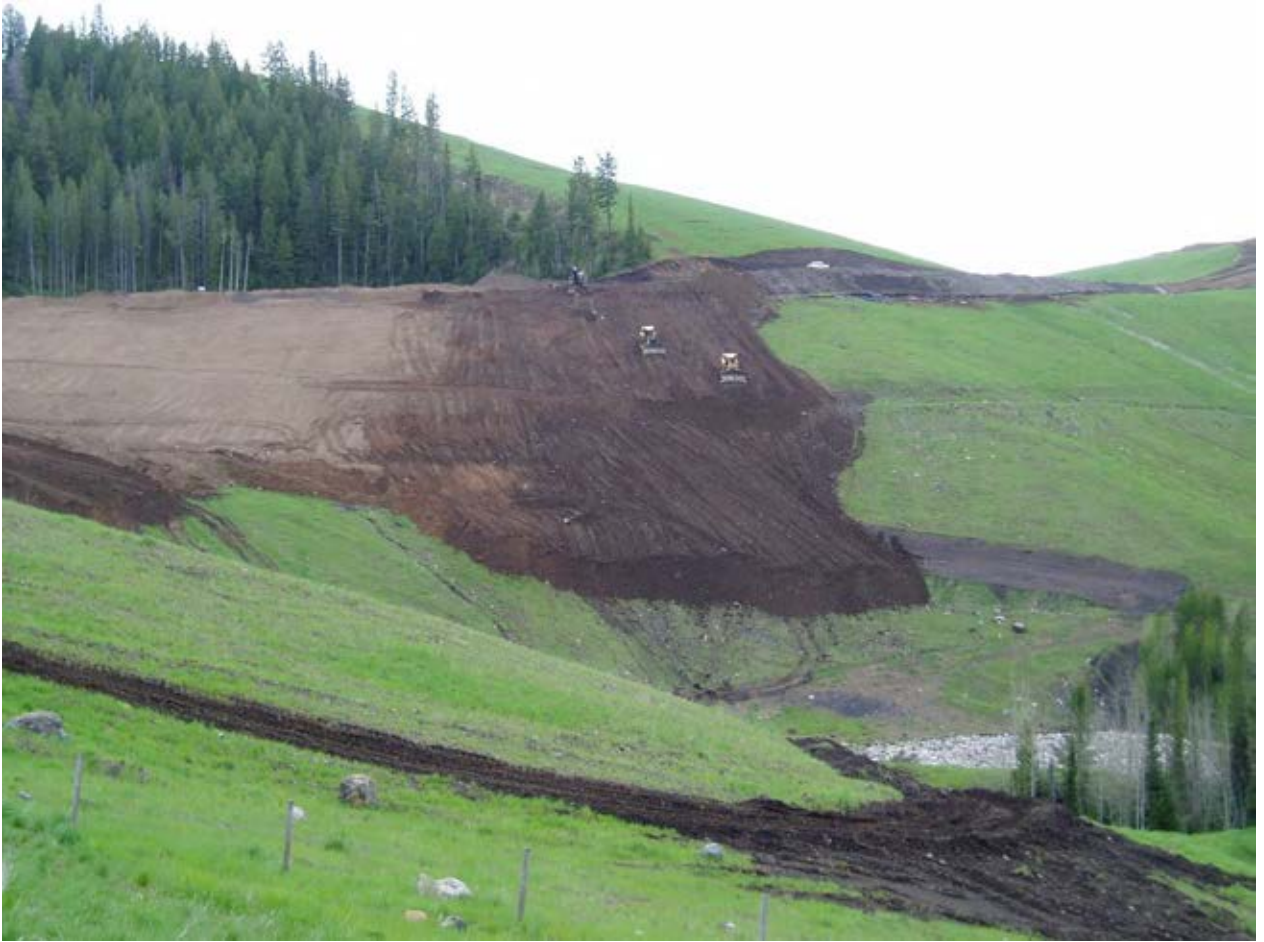
Photograph 2: Looking south at WS-R2-W and WS-R2. Dozers are pushing chert down slope from WS-R2 stockpile and excavator is potholing to confirm minimum 2 feet of chert cover has been placed.

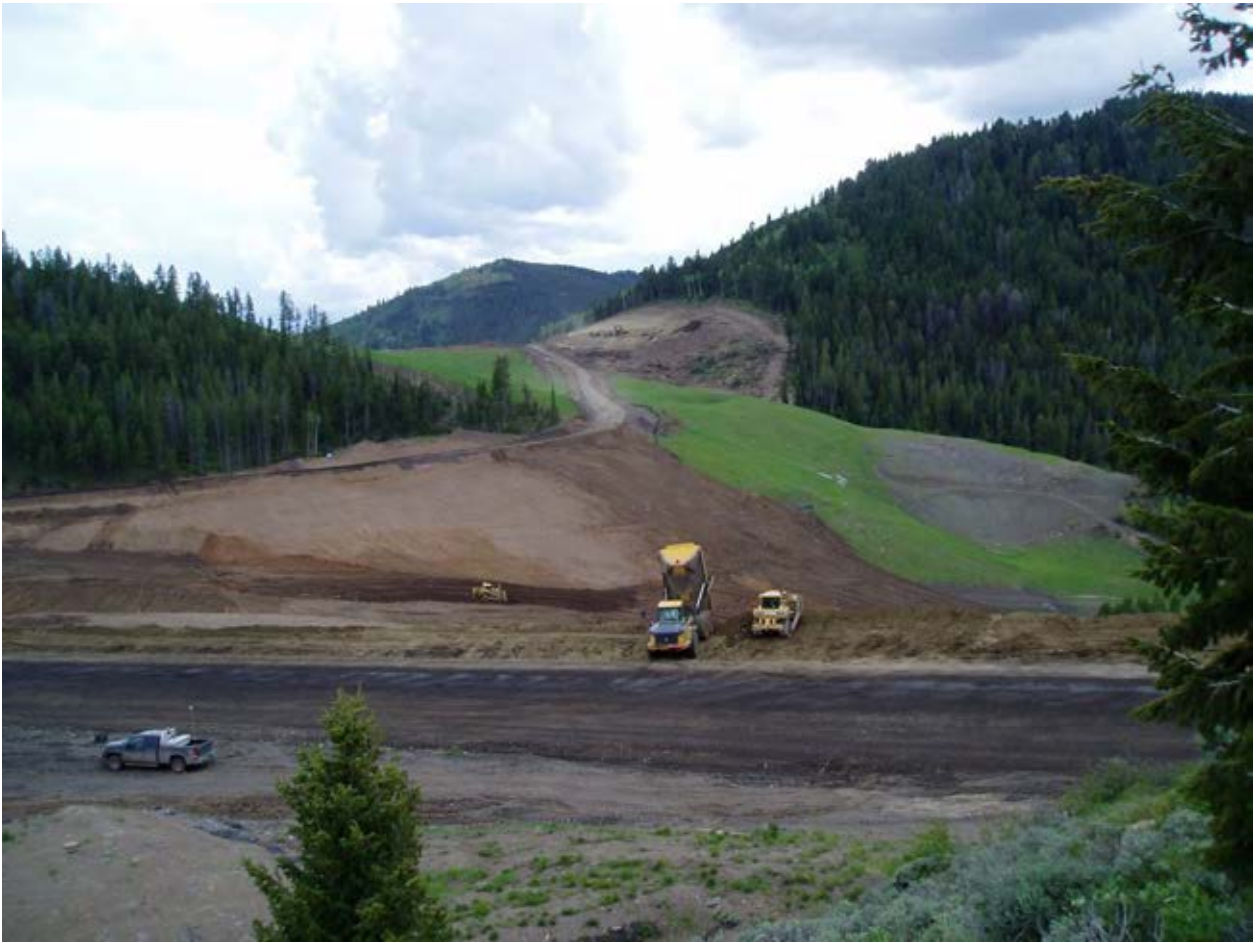
Photograph 3: Looking southwest towards Dinwoody borrow area. Haul trucks are hauling Dinwoody material from borrow area to WS-R1. Dozer in foreground is maintaining rind and safety berm. Dozer in mid-ground is pushing chert downslope on WS-R2-M.

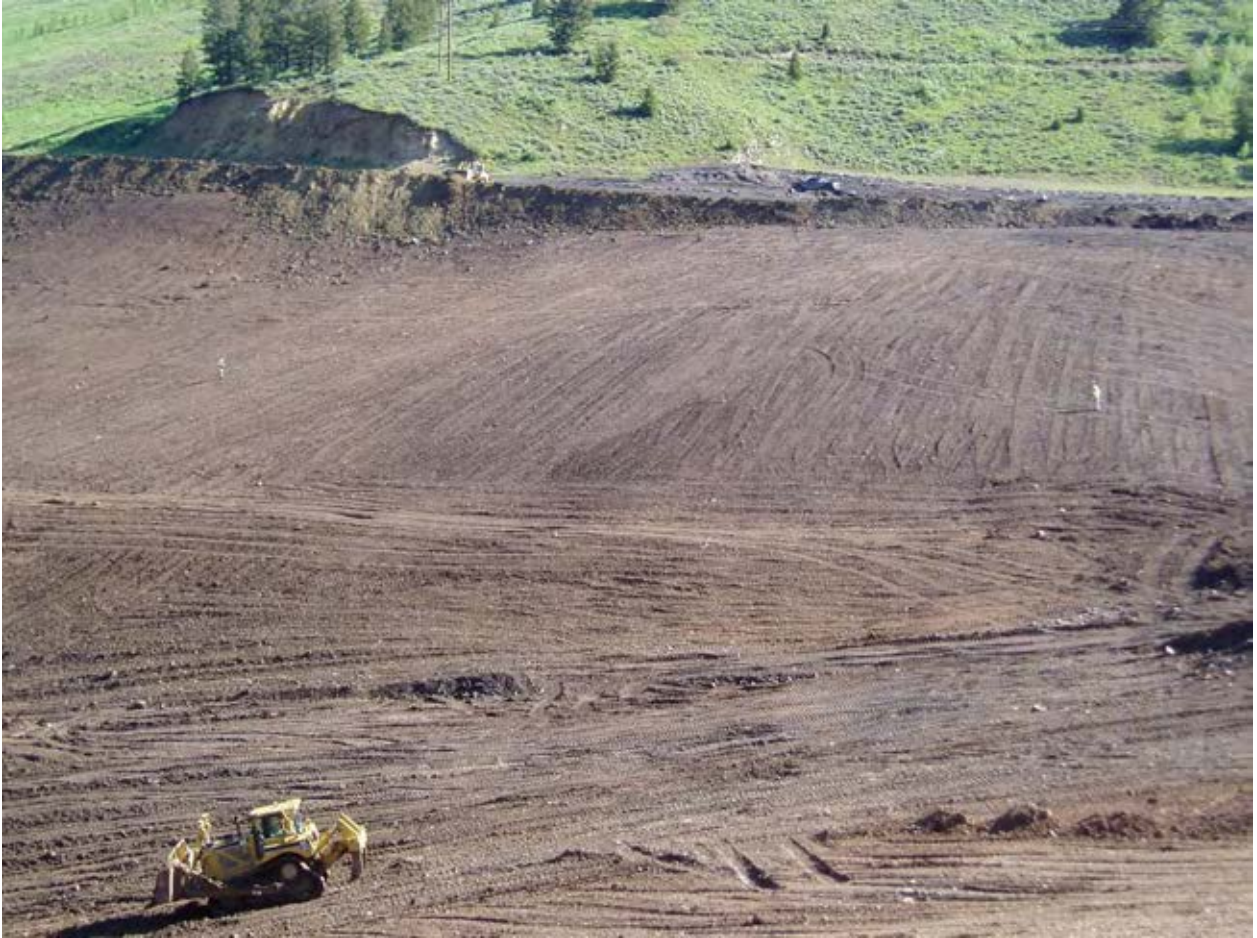
Photograph 4: Looking northeast towards WS-R1, WS-R1-W and WS-R1-M. Surveyors are confirming layer thickness by taking shots on top of the chert layer.

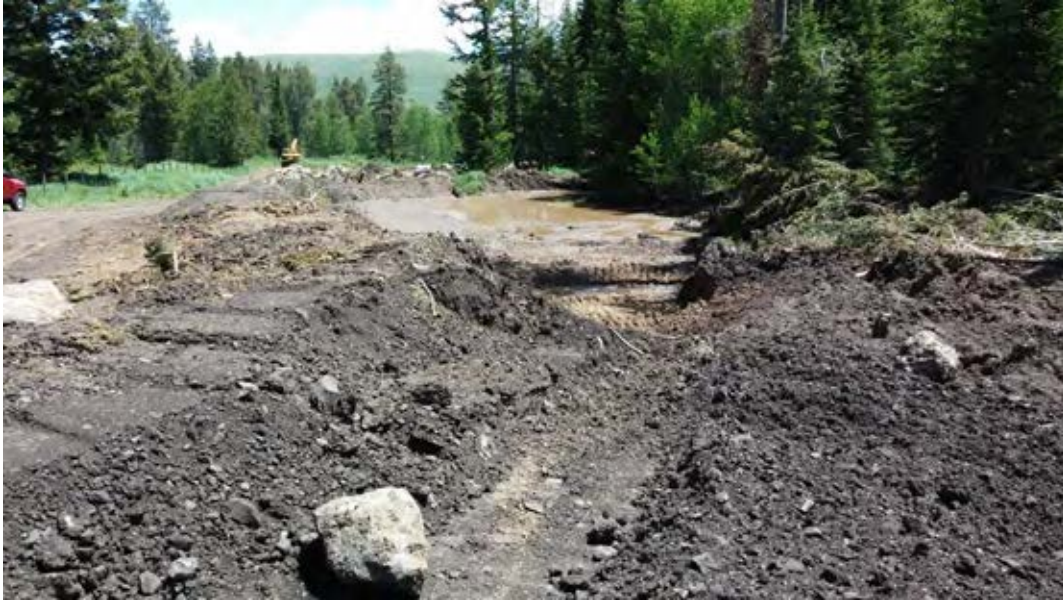
Photograph 1a: Looking east towards temporary sedimentation pond east side ODA following clean-up several days after the June 9 storm event.

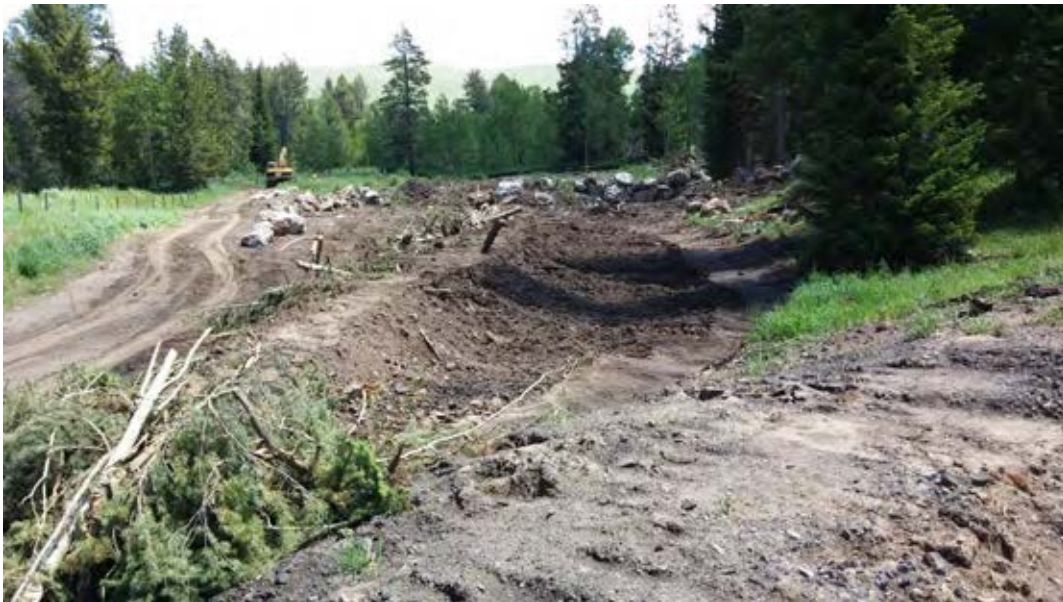
Photograph 1b: Looking east downstream of temporary sedimentation pond east side ODA following clean-up several days after the June 9 storm event.

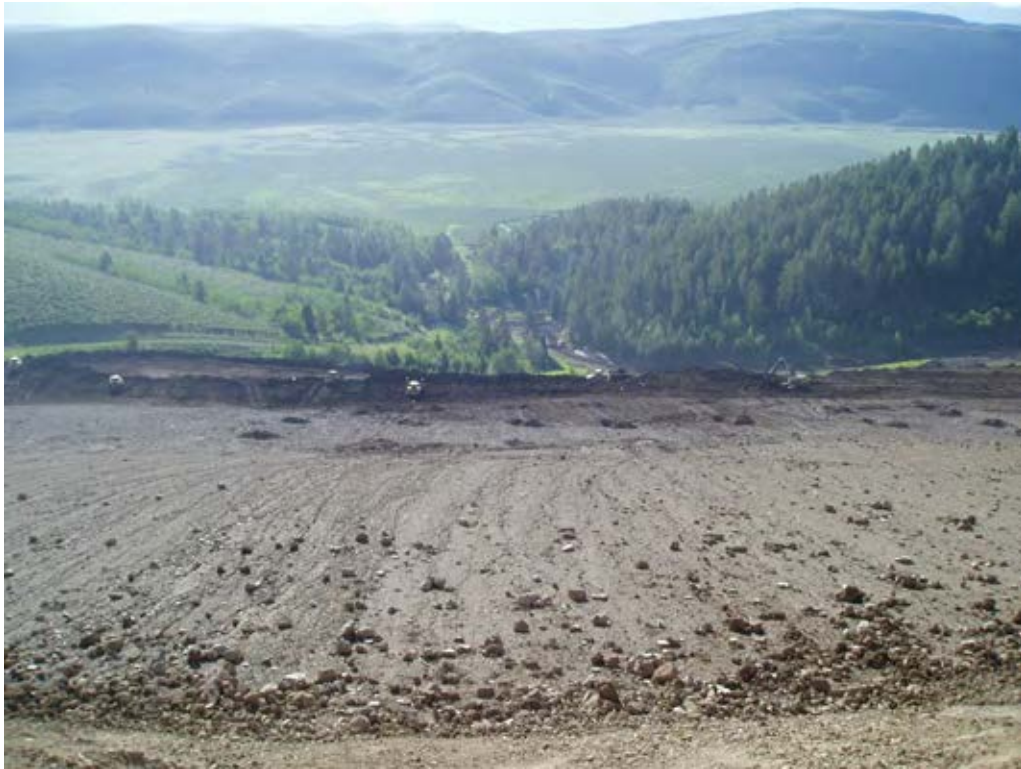
Photograph 2a: Looking east down east slope of ODA. Dozers are pushing chert onto ES-R2-N and ES-R2-M. Test pits above rind excavated as part of QC to maintain required thickness.

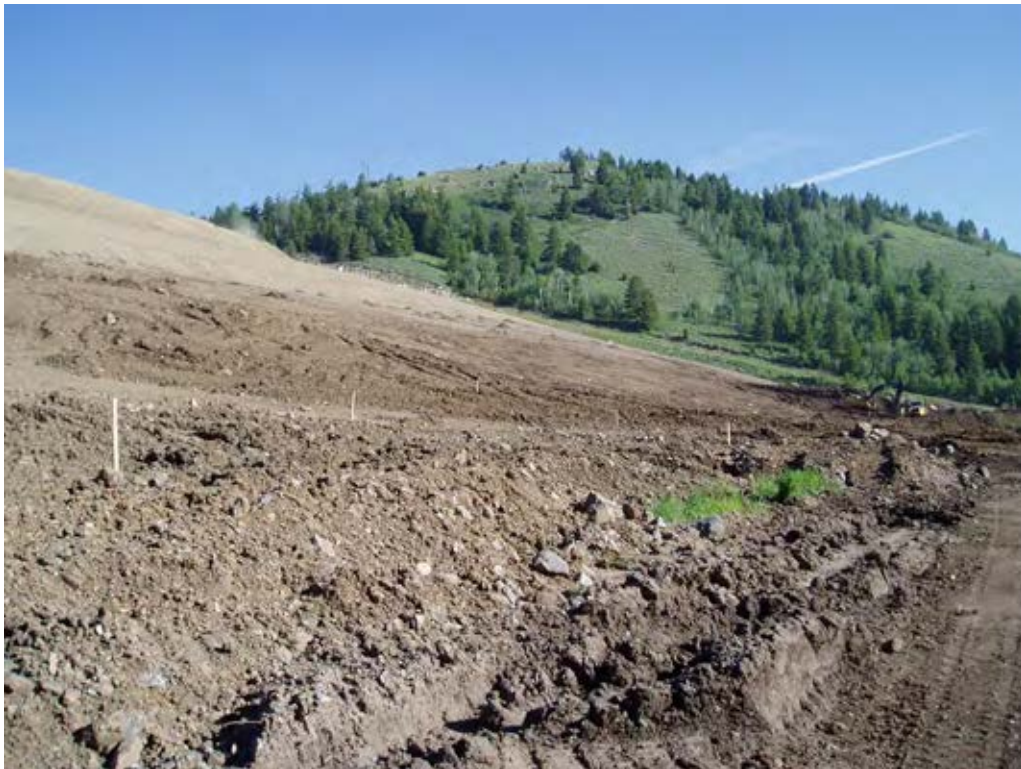
Photograph 2b: Looking northwest towards east slope of ODA. Confirmation of cover thickness (chert) maintained by continuous survey by use of grade stakes and test pits.

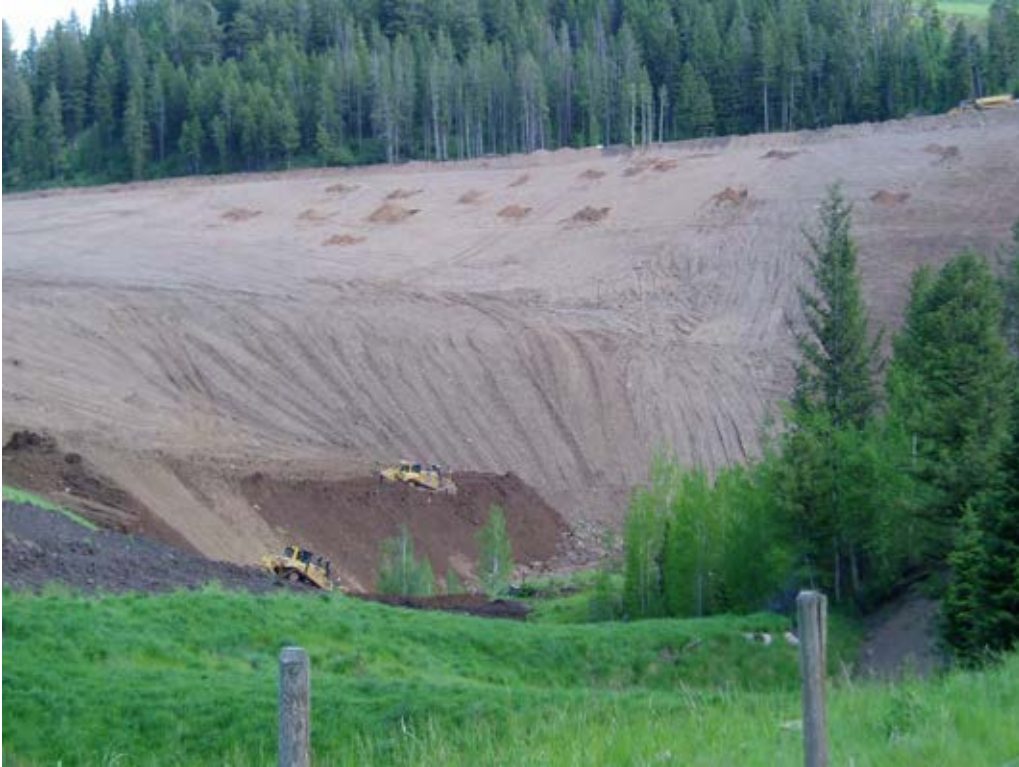
Photograph 3a: Looking south at WS-R2-W. Dozers advancing chert cover on lower WS-R1-W and WS-R2-W. Test pits to confirm chert layer thickness excavated on upper WS-R2-W.

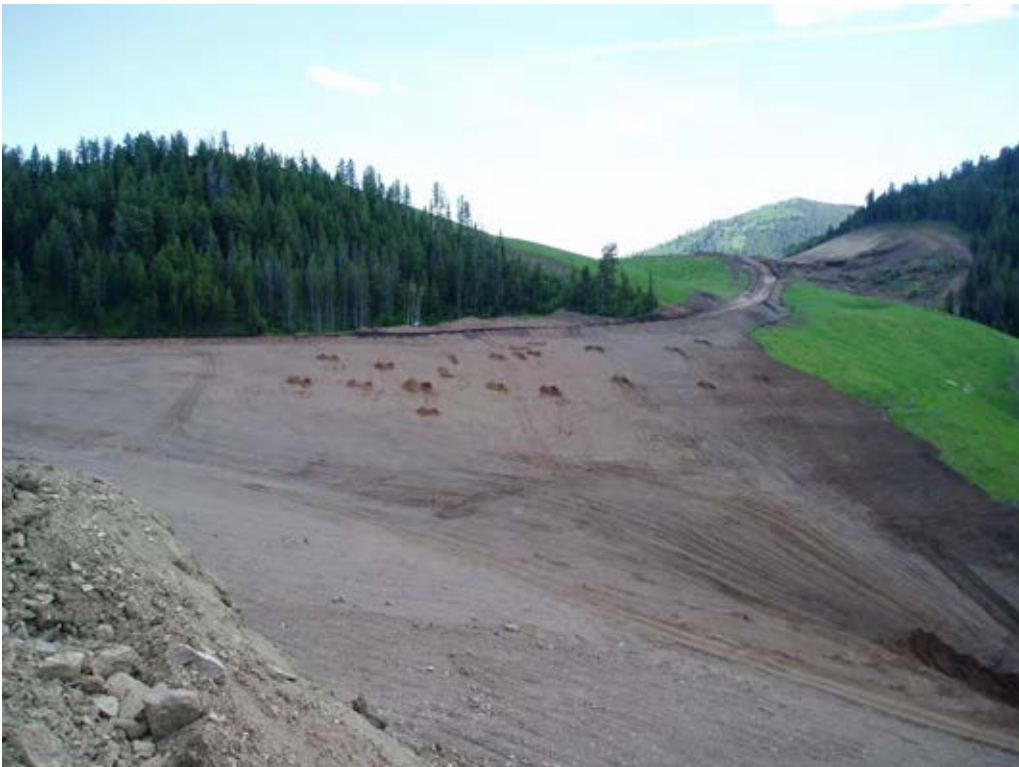
Photograph 3b: Looking southwest towards upper WS-R2-W and north end of Dinwoody borrow. Test pits excavated to monitor and confirm chert thickness.

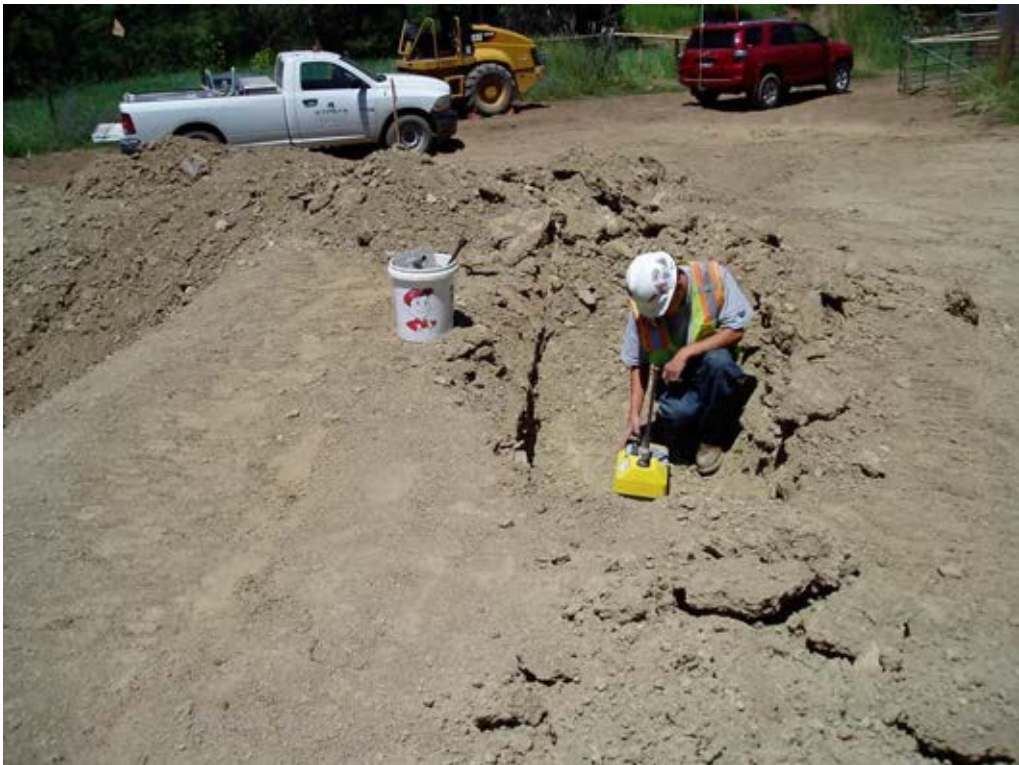
Photograph 3b: Looking north along downstream berm crest of East Sedimentation Basin at Strata field engineer checking soil compaction with nuclear densometer.

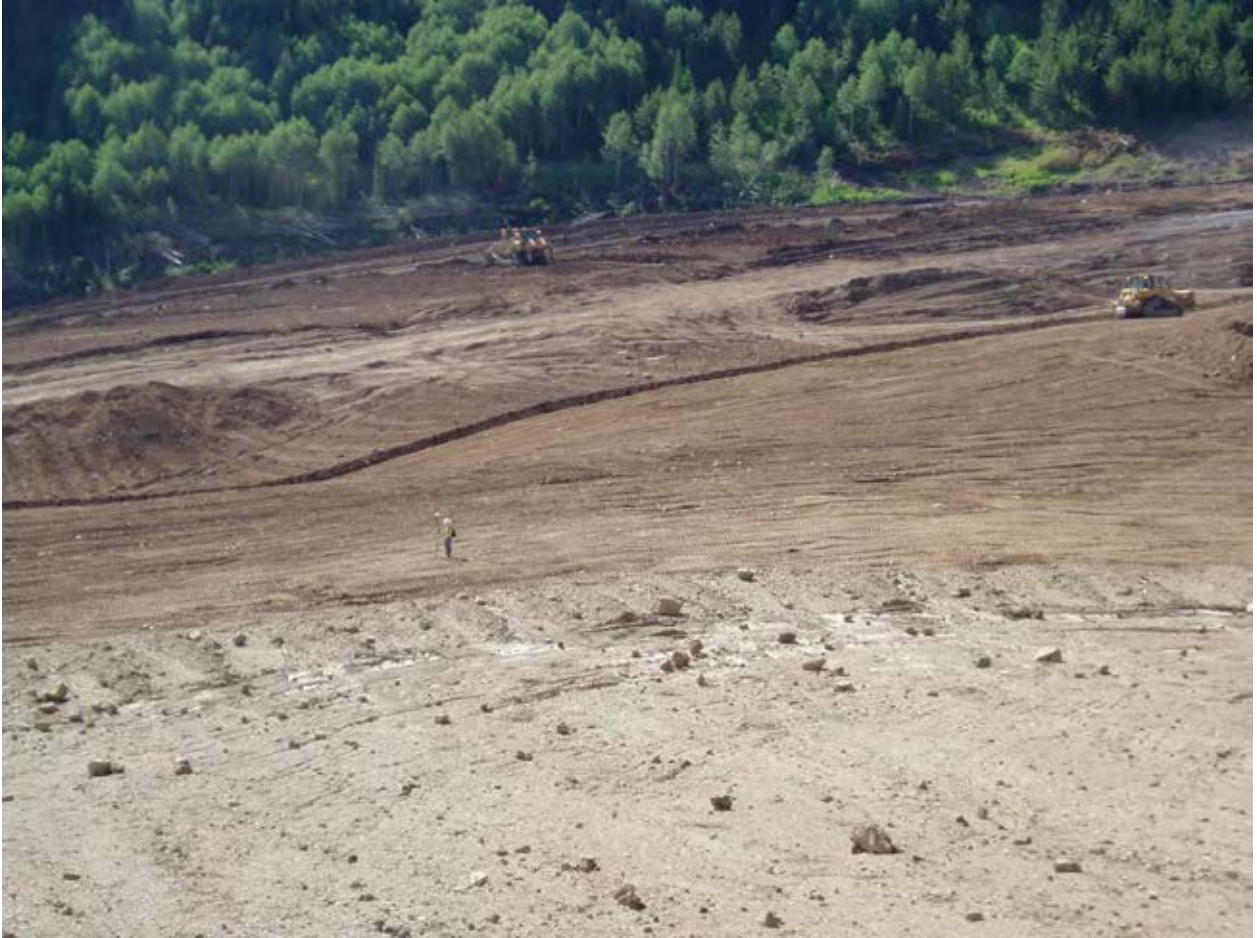
Photograph 4: Looking southeast from top of east side ODA. Survey grade check taking total station readings to confirm chert layer thickness on lower ES-R1-M.

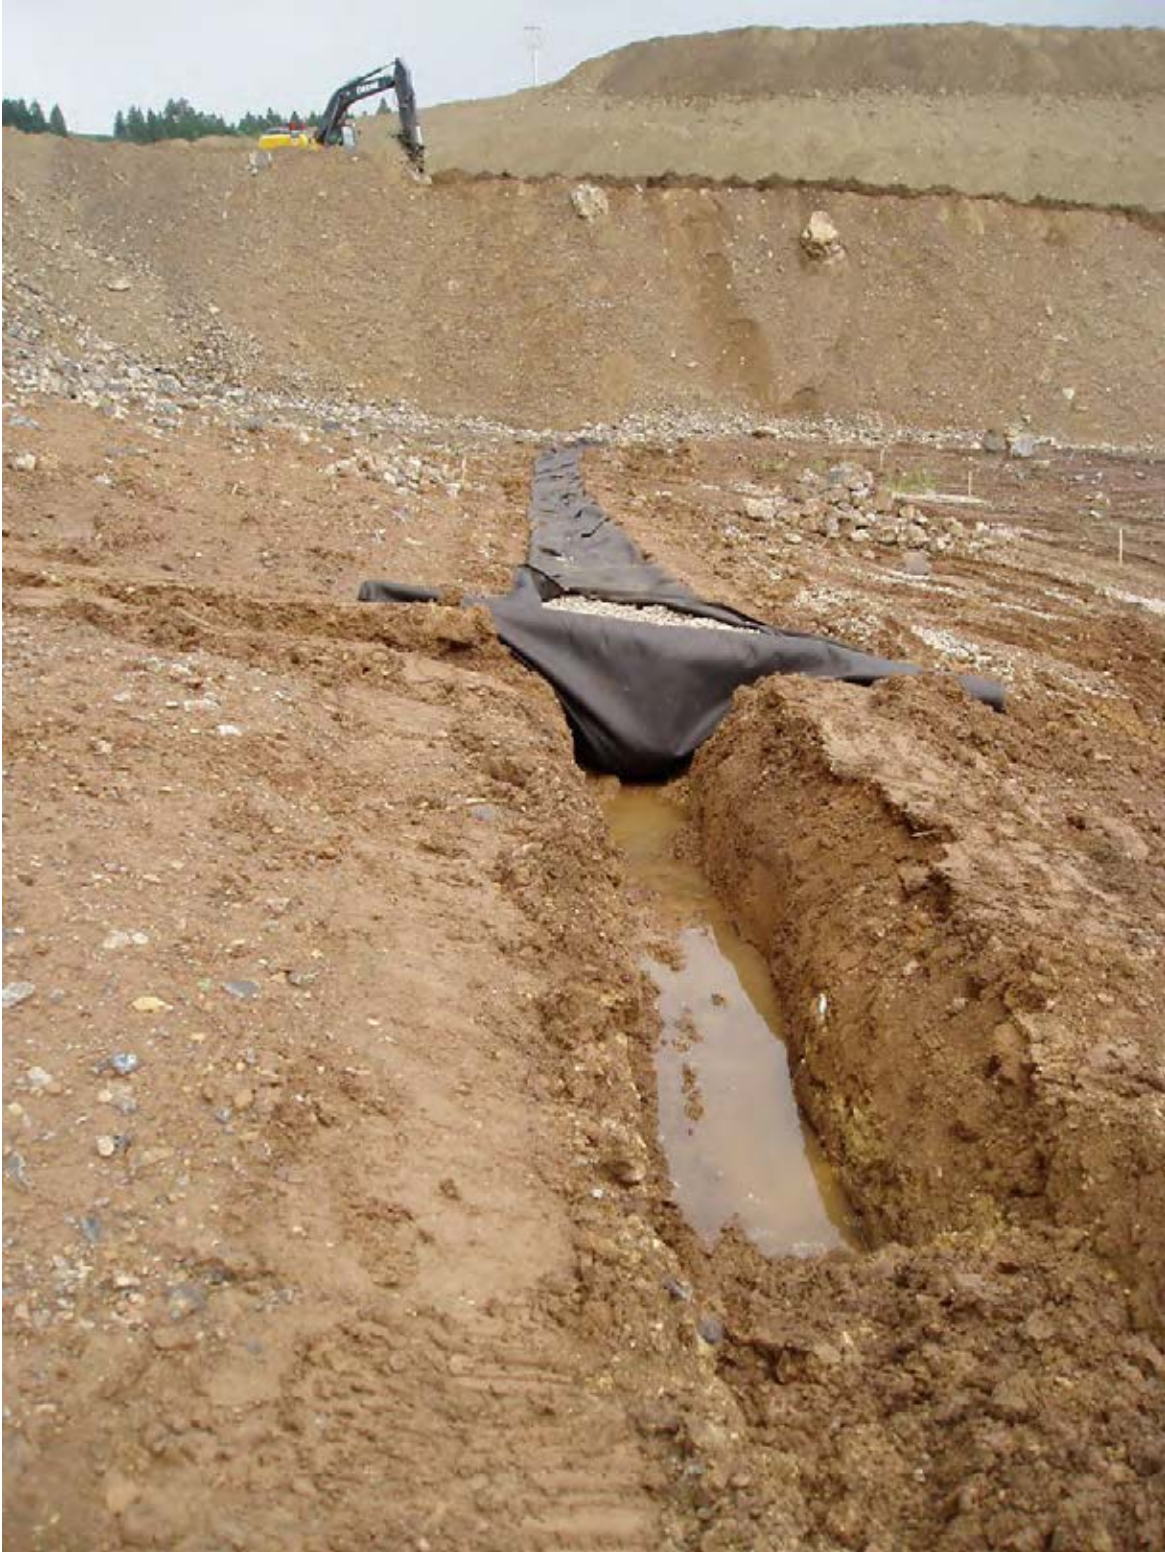
Photograph 1a: Looking north along groundwater seep interceptor underdrain just west of South Central Sedimentation Basin. Trench is sloping 1.5% to the south.

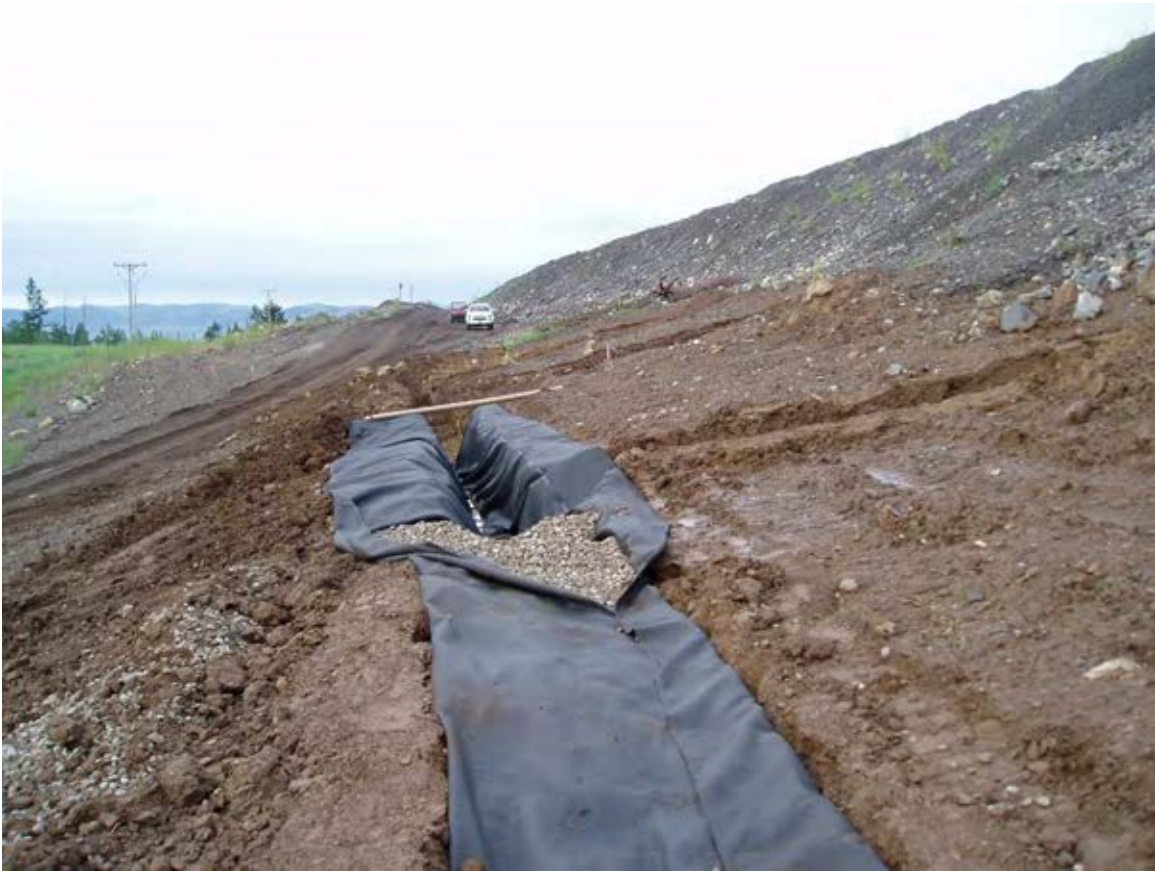
Photograph 1b: Looking south along groundwater seep interceptor underdrain just west of South Central Sedimentation Basin. Trench is sloping 1.5% to the south.

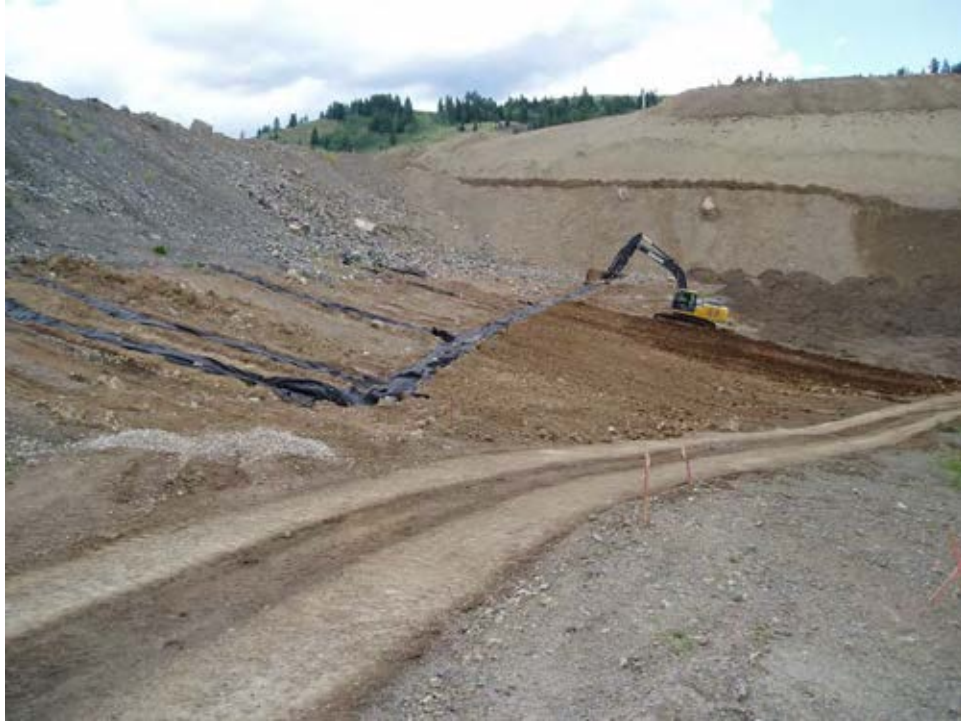
Photograph 1a: Looking north along seep collection underdrain immediately west of South Central Sedimentation Basin. Underdrain is excavated 2 feet deep, 3 feet wide, lined with 12 oz/sy non-woven geofabric and filled with 2 inch minus gravel containing less than 1% fines.

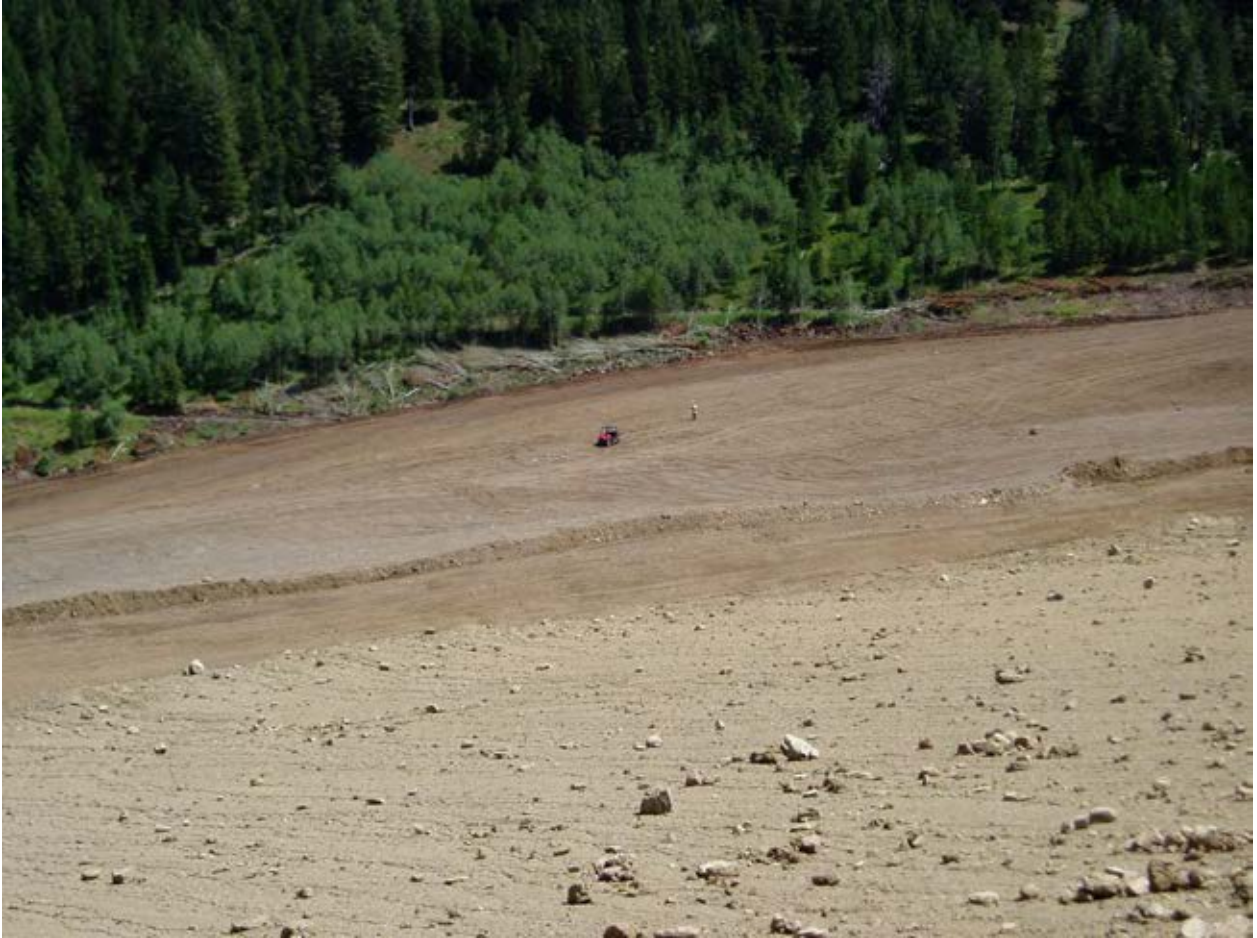
Photograph 5: Looking downslope east face of east side of ODA. Survey grade check verifying chert layer thickness ES-R2-S with GPS unit.

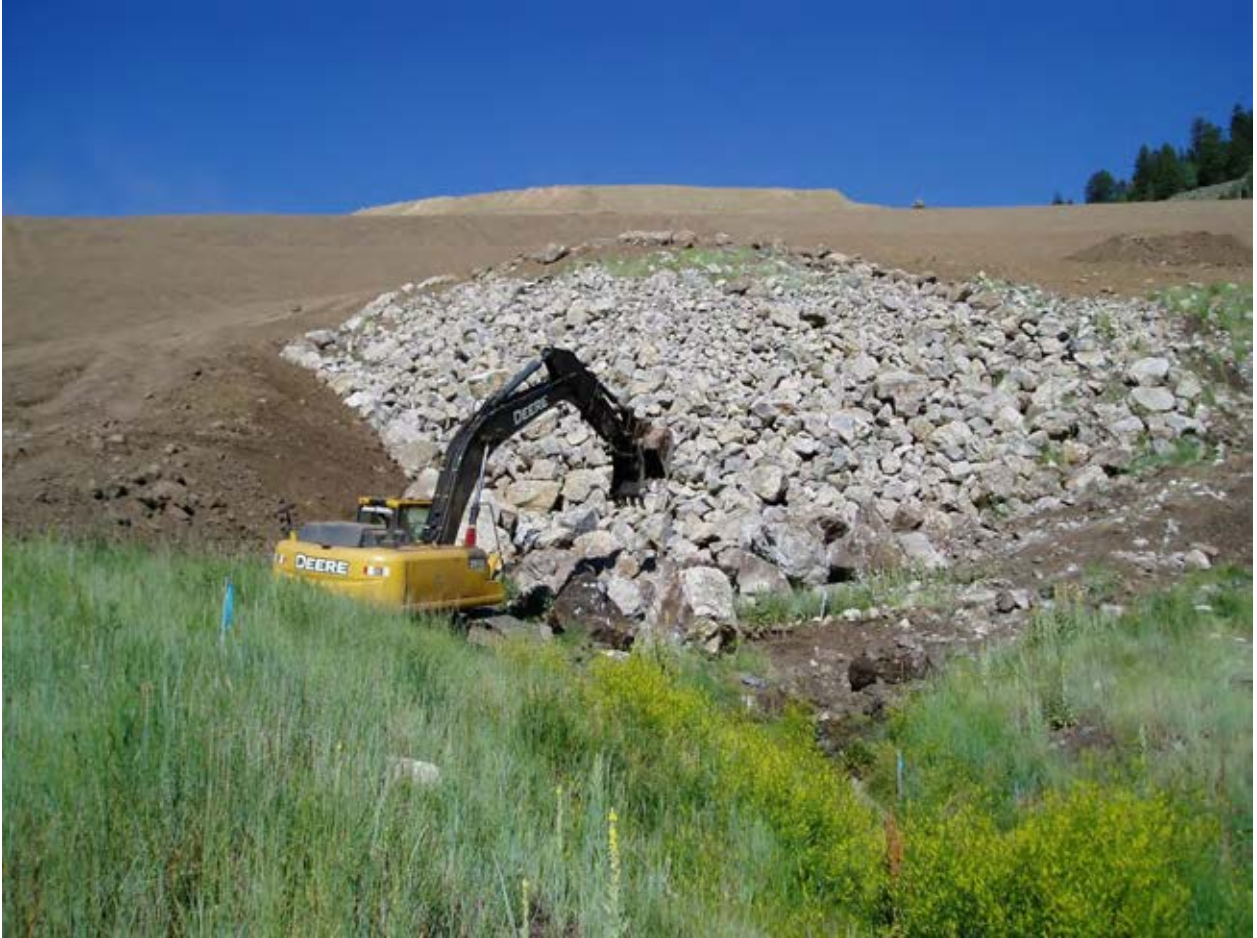
Photograph 4: Looking west at chert material being tied into rock buttress at toe of the east side ODA.
